IRAQI CIVIL DEFENSE  
HEADQUARTERS  
BAGHDAD, IRAQ

**SIGIR PA-06-090**  
**APRIL 26, 2007**

SUBJECT: Report on Iraqi Civil Defense Headquarters, Baghdad, Iraq (Report Number  
SIGIR PA-06-090)

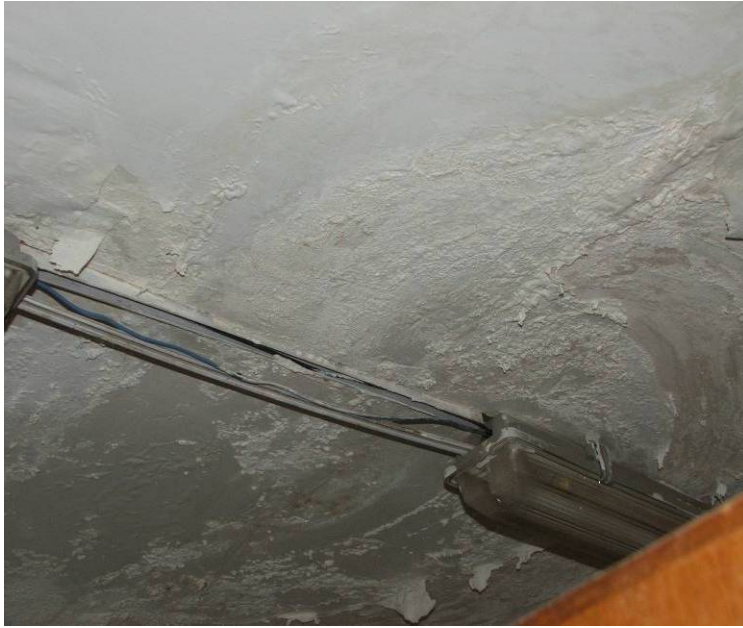
During our site visits, we identified water damage within the ICD HQ bathrooms (Site Photos 7 and 8). Our observations, coupled with discussions with ICD HQ personnel and review of daily QA reports, suggest the bathroom plumbing installation did not adhere to the standards of the IPC.

**Site Photo 7. Water damage to ceiling of 1<sup>st</sup> floor bathroom**  
(Photo courtesy of the USACE)

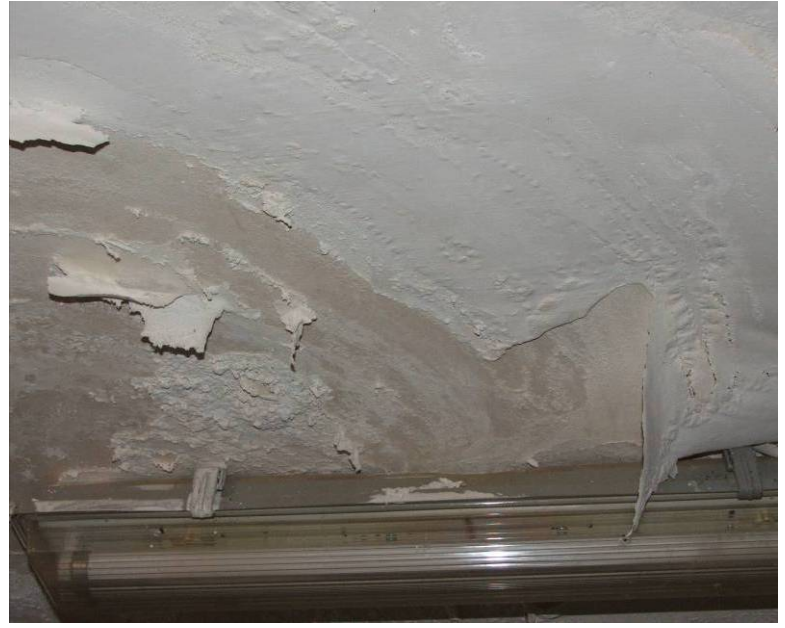
**Site Photo 8. Additional view of water damage to ceiling**  
(Photo courtesy of the USACE)

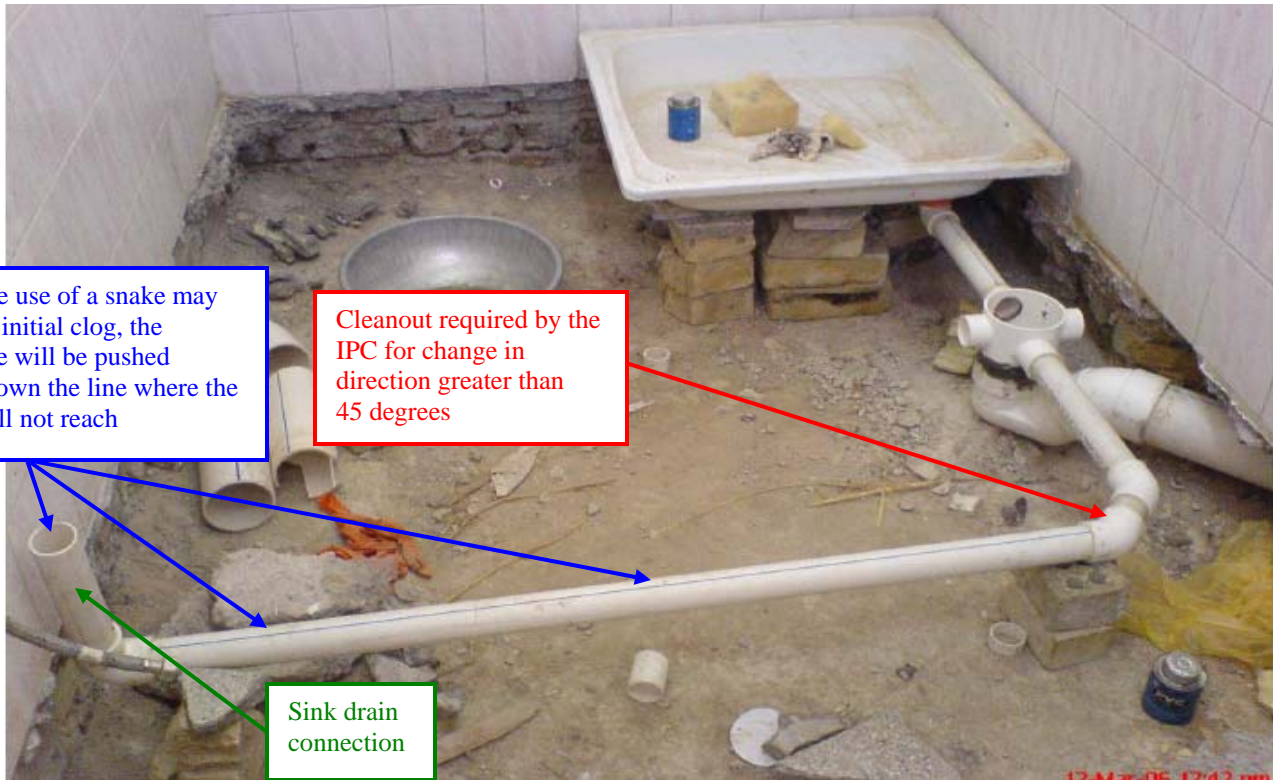
The as-built drawings for the ICD HQ bathrooms indicate cleanouts were only used at the far end of a straight run of soil pipe, not for every toilet trap and change of direction (Figure 7). Since the 30% and 60% design drawings were unavailable for our review, we cannot determine whether the government engineers reviewing the bathroom design drawings failed to detect and identify the lack of sufficient number of cleanouts and traps at the correct locations. However, the government design reviews do not mention the absence of cleanouts and traps at the correct locations as a deficiency.

**Site Photo 9. Plumbing installation techniques used by the subcontractor – specifically, a lack of required cleanouts (Photo courtesy of the USACE)**

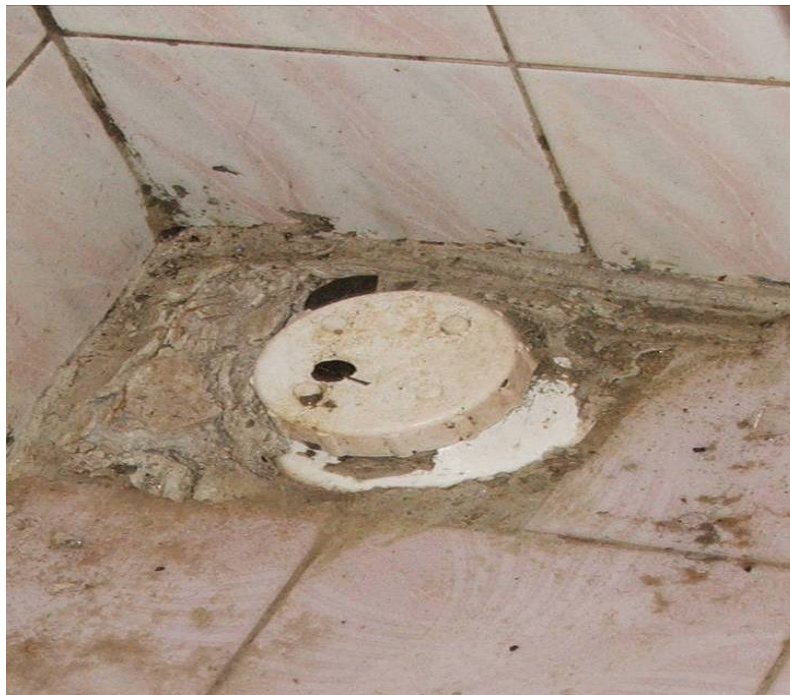
In addition, GRD representatives stated that having a single cleanout at the end of a straight run of soil pipe was adequate. However, we identified instances where the subcontractor used poor installation techniques for the single cleanout (Site Photo 10). The top has been cemented and will not come off to allow access to the cleanout, which rendered this cleanout useless for any type of maintenance and/or repair purposes.

**Site Photo 10. Cleanout at the end of a straight lateral run of 6-inch sewer pipe. Poor installation resulted in the cleanout being unusable.**

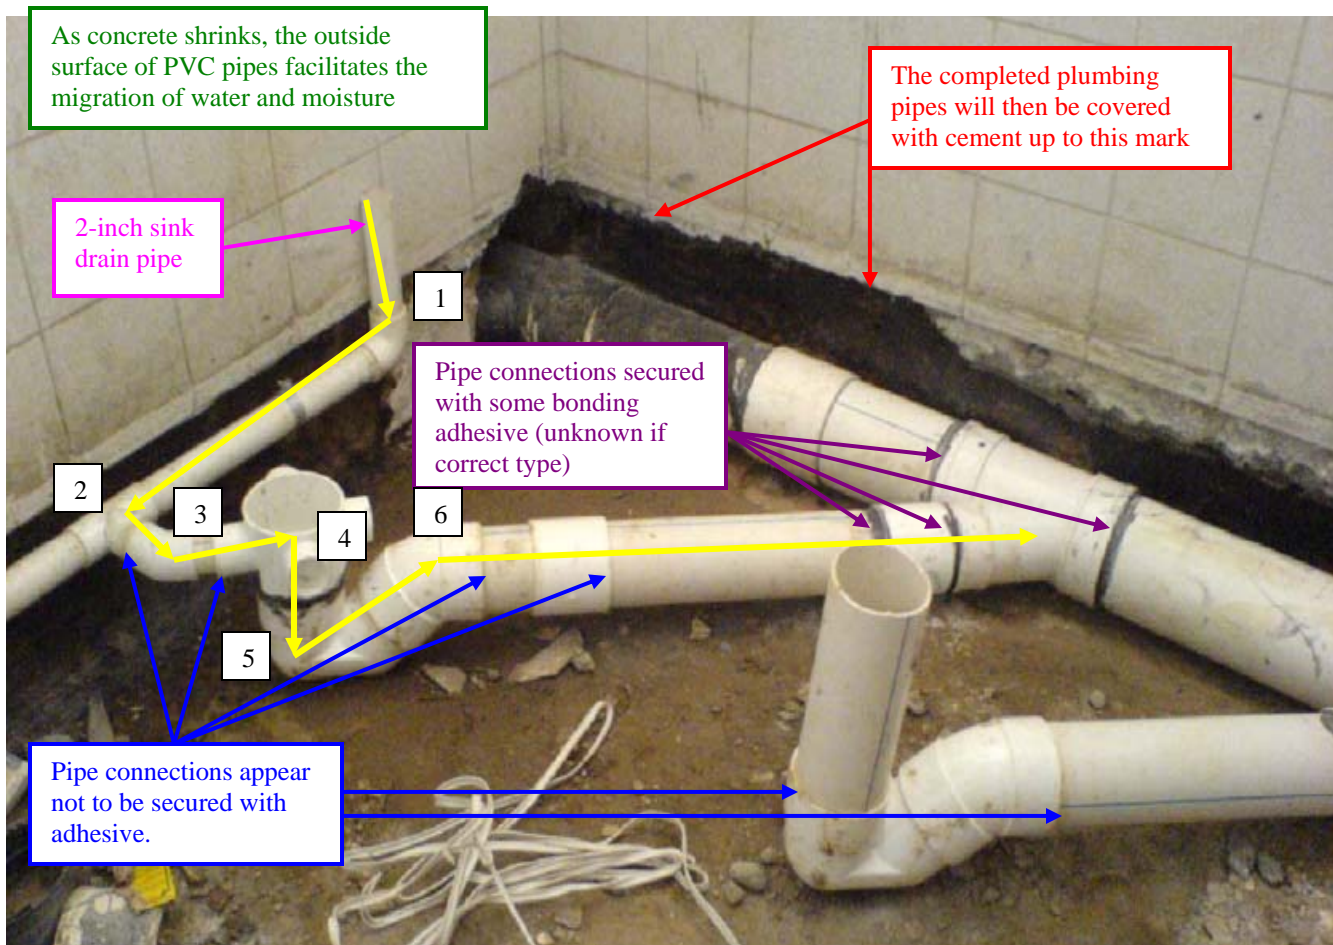
Finally, Site Photo 11 illustrates another design and installation problem with the bathroom plumbing. The photo shows a 2-inch sink drain pipe, which needs to make 6 turns in order to flow into the main 6-inch sewer line. These unnecessary numbers of connections exponentially increases the chances of sentiment clogs and leaks.

**Site Photo 11. Subcontractor's bathroom plumbing assembly prior to pouring cement**  
(Photo courtesy of the USACE)

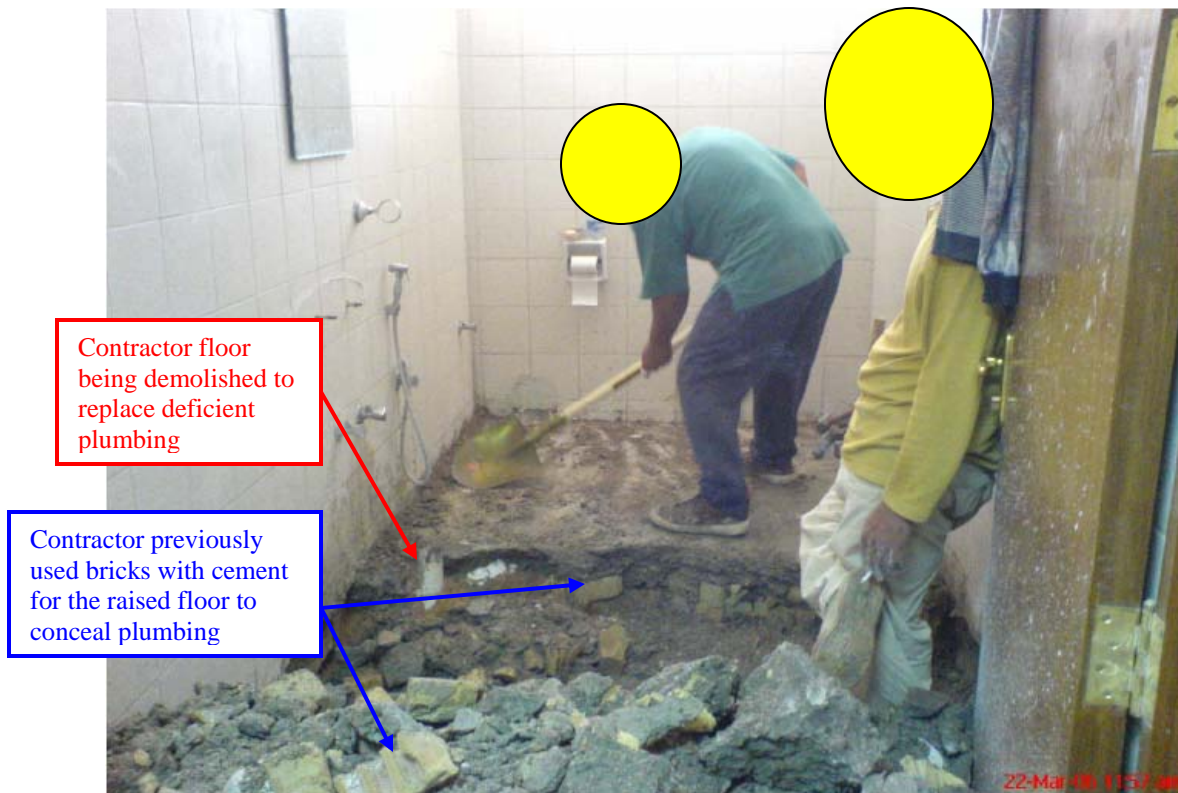
be dug up in order to identify and correct the source. The subcontractor experienced this problem in March 2006 when significant leaks from the original bathroom plumbing were identified. The subcontractor had no alternative but to completely demolish the bathroom floors to locate, identify, and replace the faulty plumbing (Site Photo 13). Site Photo 13 also shows that the subcontractor used full and partial bricks as aggregate within the cement mix for the raised floor.

**Site Photo 13. Burying the plumbing pipes required demolishing the floor to correct poor installation techniques** (Photo courtesy of the USACE)

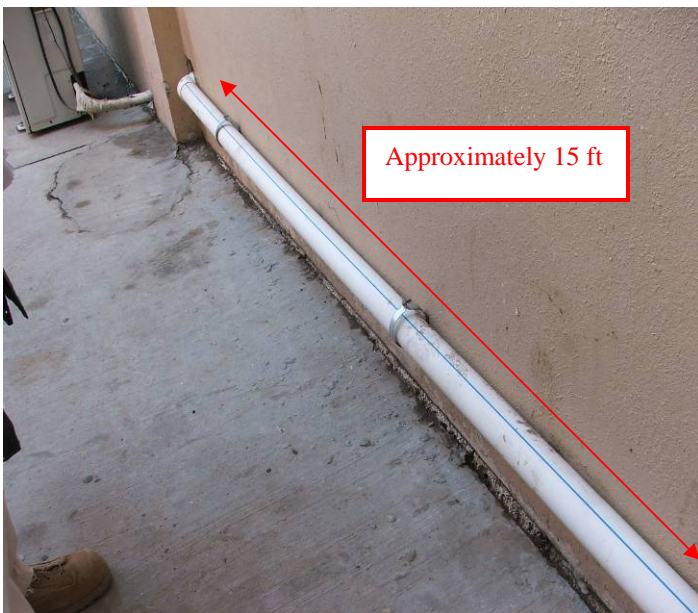
We identified approximately 15 feet of exposed plumbing sewer pipes leading from the ground floor bathroom to the outside manhole (Site Photos 14 and 15). The exposed sewer pipes are not protected. For example, the sidewalk shown in Site Photo 15 is less than five feet from the entrance/exit of the Operations Room. Any ICD HQ personnel not paying attention may trip over the exposed pipe, resulting in potential injury or breaking the pipe. In addition, PVC pipe is not designed to withstand excessive temperatures and the typical Iraqi summer will eventually cause the pipes to crack. Broken and/or cracked exposed sewer pipes will create environmental and health hazards for the ICD HQ personnel.

**Site Photo 14. Exposed PVC plumbing pipe running from ground floor bathroom to sewer manhole**

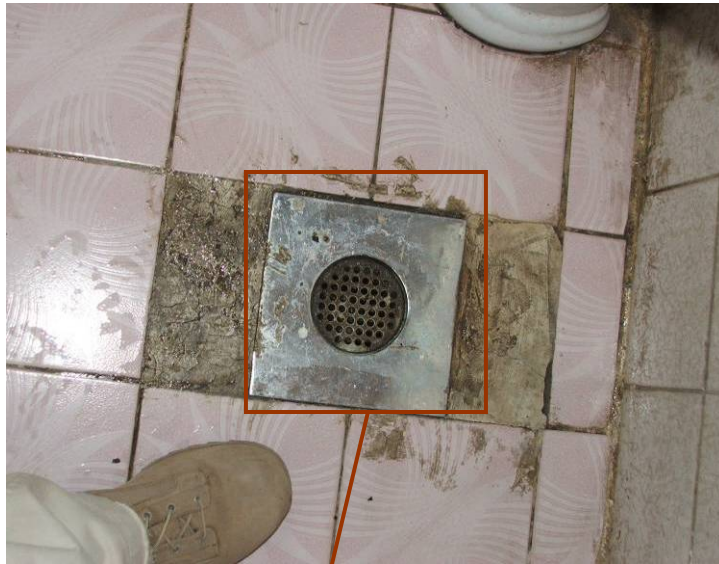
- Floor drains are not adequately sealed to the floor surface and/or properly affixed to adjacent fittings with the proper adhesive or sealant, which causes water to drain outside rather than inside the drain collectors (Site Photos 16 and 17).
- Bathroom and janitor rooms were not adequately water proofed.

**Site Photo 16. First floor bathroom floor drain**

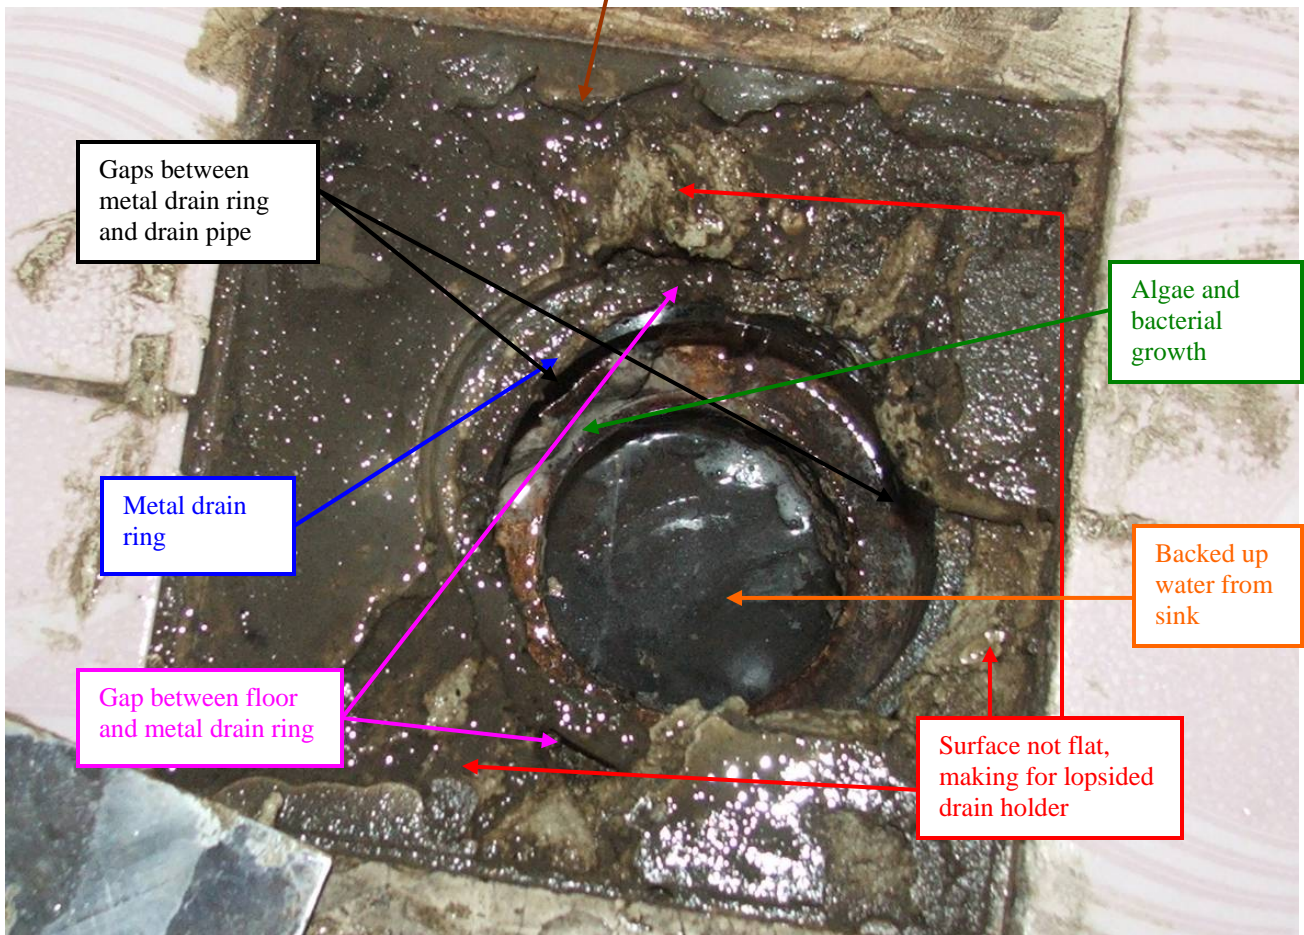
During our site visit, we lifted a drain cover, which exposed a pooling of sewer water and germs collecting underneath. The contractor did not properly seal the drain cover into the mortar, allowing water to seep underneath, which facilitated the growth of algae. We found cracks, voids, holes, and openings around the drain pipe in the floor. These

**Site Photo 17. Close-up view of first floor drain with cover removed**

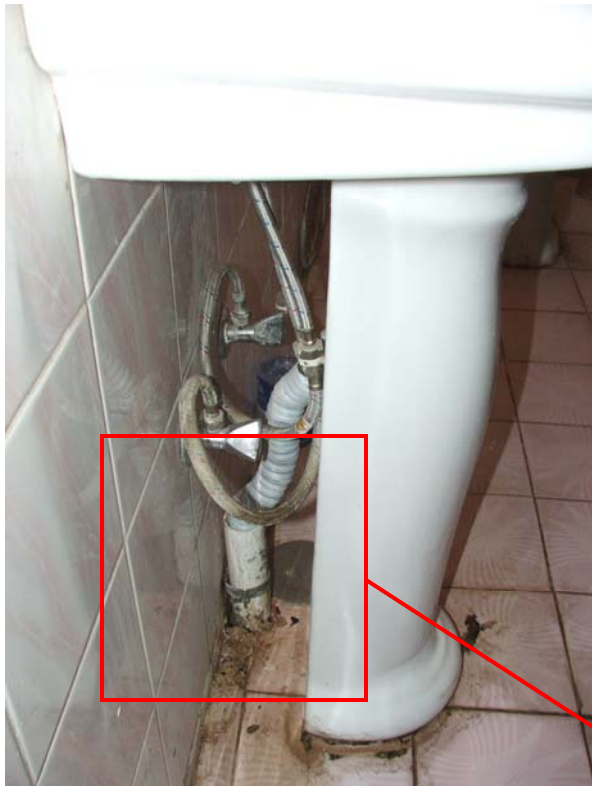
The Iraqi practice of cementing around PVC pipe is deficient because cement does not adhere to PVC pipe. Water proofing the bathroom and janitor rooms is crucial for two reasons. First of all, if the sinks and/or toilets leak or overflow, any opening will allow the water an opportunity to penetrate. In addition, the Iraqi custom is to clean bathrooms and janitor rooms by pouring a large amount of water onto the floor and squeegee the water into the drain; therefore, the floors and walls must be water proofed to avoid any leaks seeping into the raised cement floor. During our site visits, we identified examples where the subcontractor's water proofing techniques were substandard (Site Photos 18 and 19). This deficient workmanship will result in water seeping through the openings and damaging the ceiling below.

**Site Photo 18. Poor installation workmanship  
(floor not completely waterproofed)**

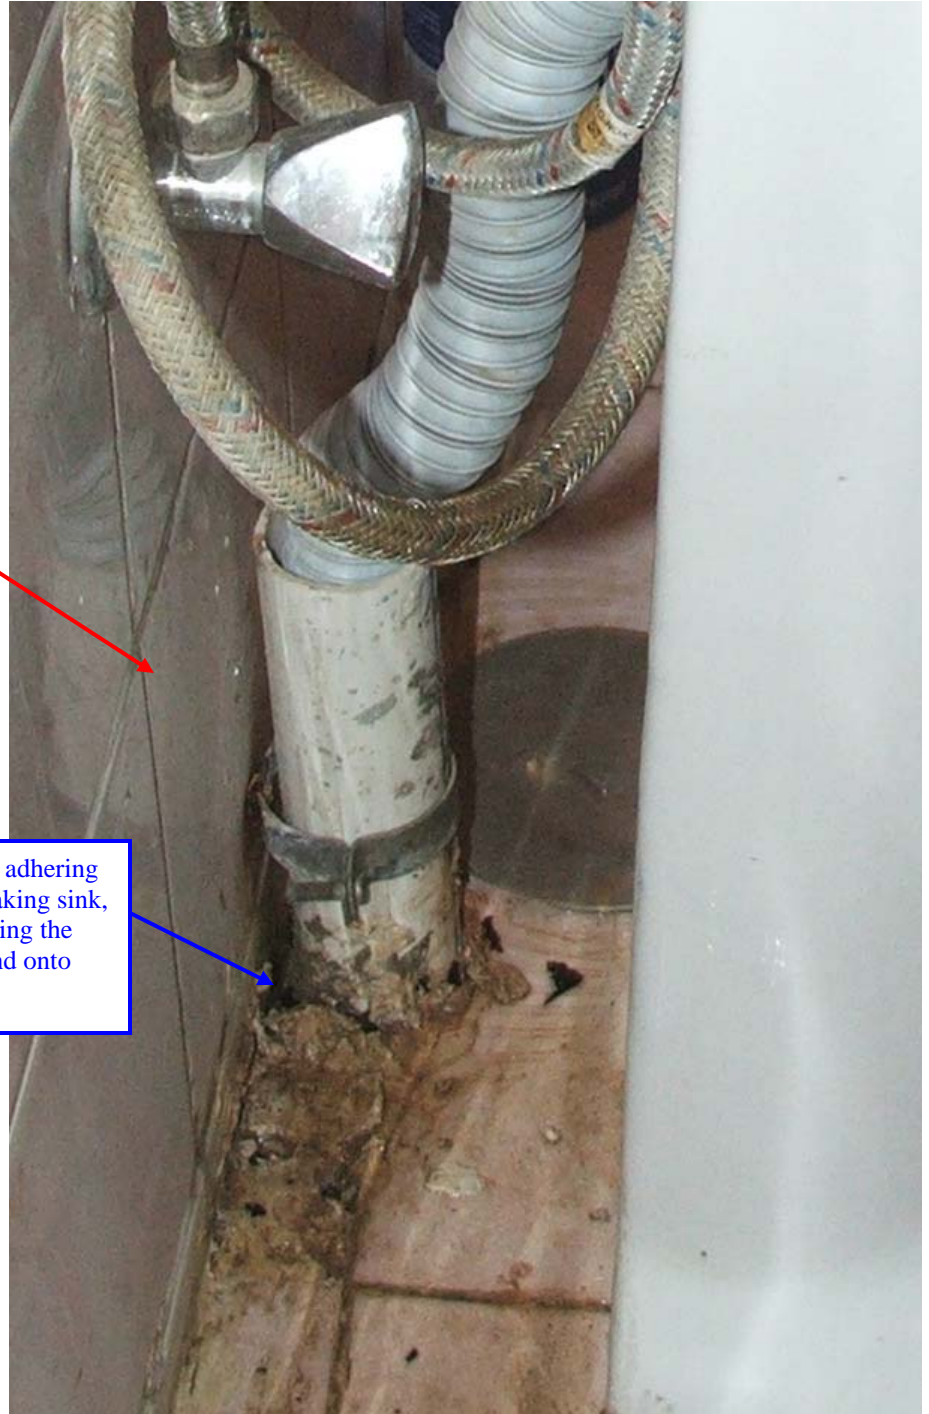
Gap resulting from cement not adhering to PVC pipe. Water from a leaking sink, overflowing toilet, or for cleaning the floor will run down opening and onto the ceiling of floor below.

**Site Photo 19. Enlarged view of Site Photo 17**

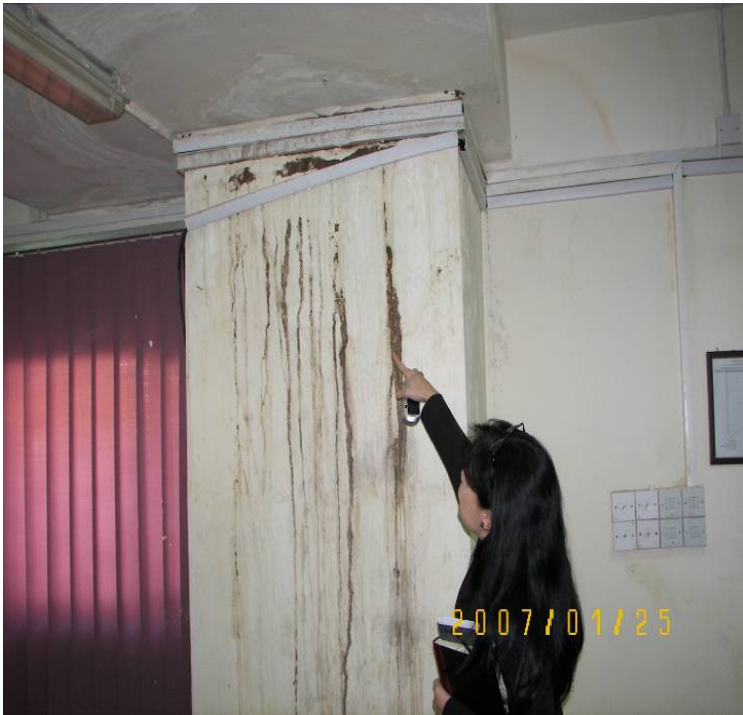
However, according to discussions with ICD HQ personnel, the water leaks resulted from poor construction techniques, specifically the subcontractor’s failure to follow the TO required IPC standards. The ICD HQ personnel stated that the dark stain on the pillar is from sewer water, and they are currently dealing with the potential for environmental and health hazards within the room by limiting its use as the designated Operations Room.

**Site Photo 20. Water damage in ground floor Operations Room**

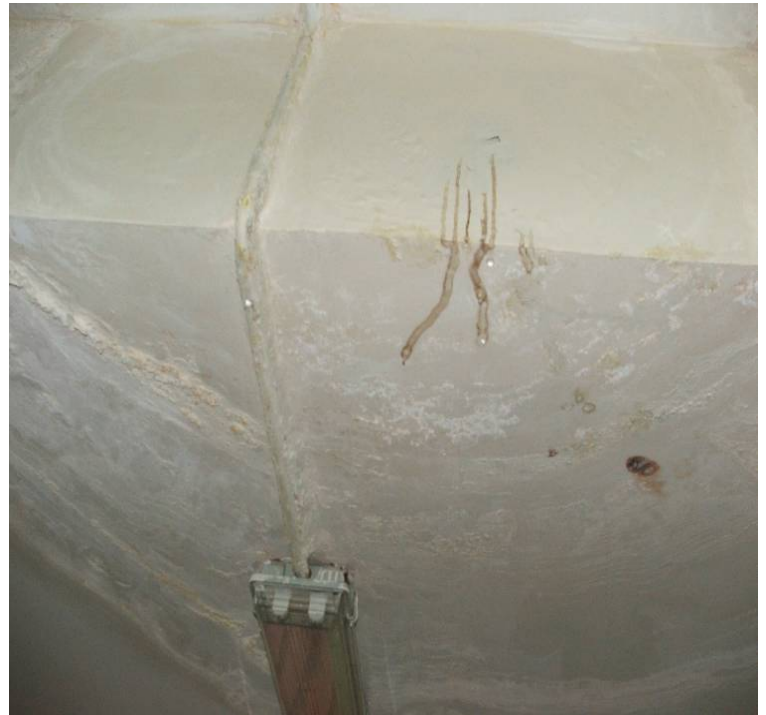
**Site Photo 21. Close up view of water damage on ceiling**

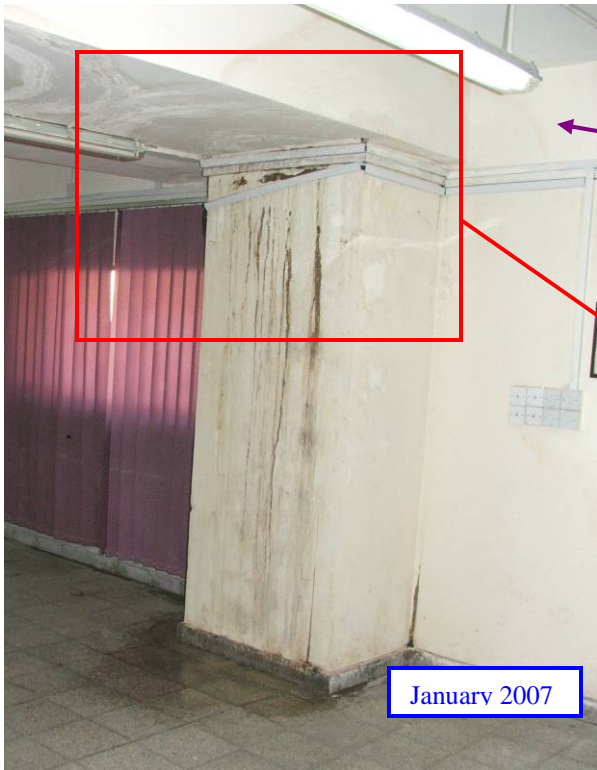
**Site Photo 23. Water damage within the ground floor Operations Room from our first site visit**

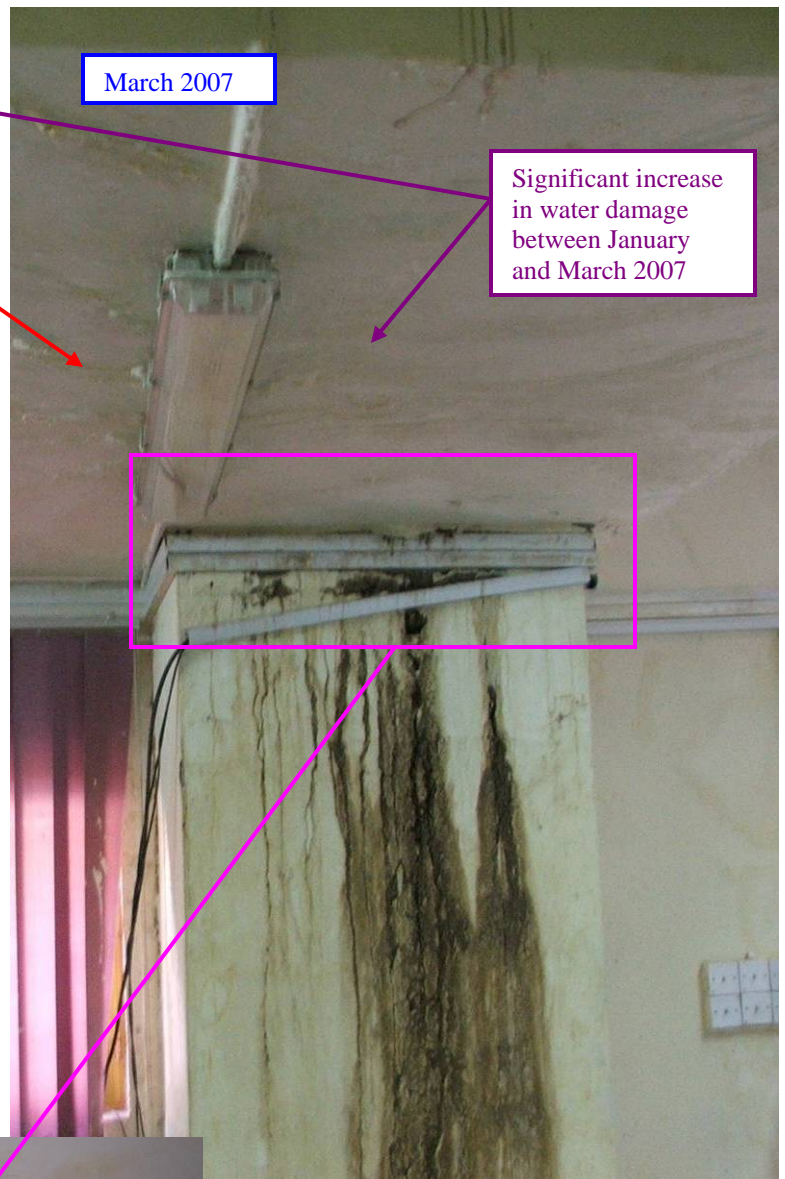
**Site Photo 24. Additional water damage to ground floor since our first site visit**

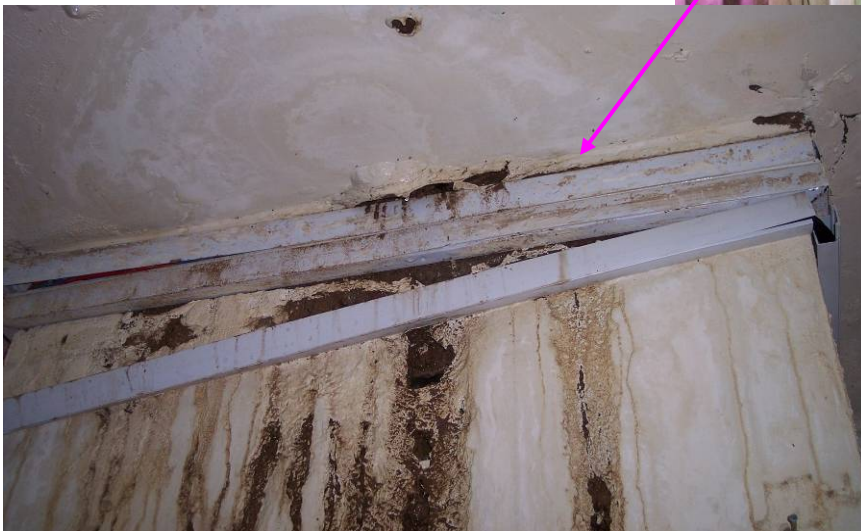
**Site Photo 25. Close-up view of water damage**

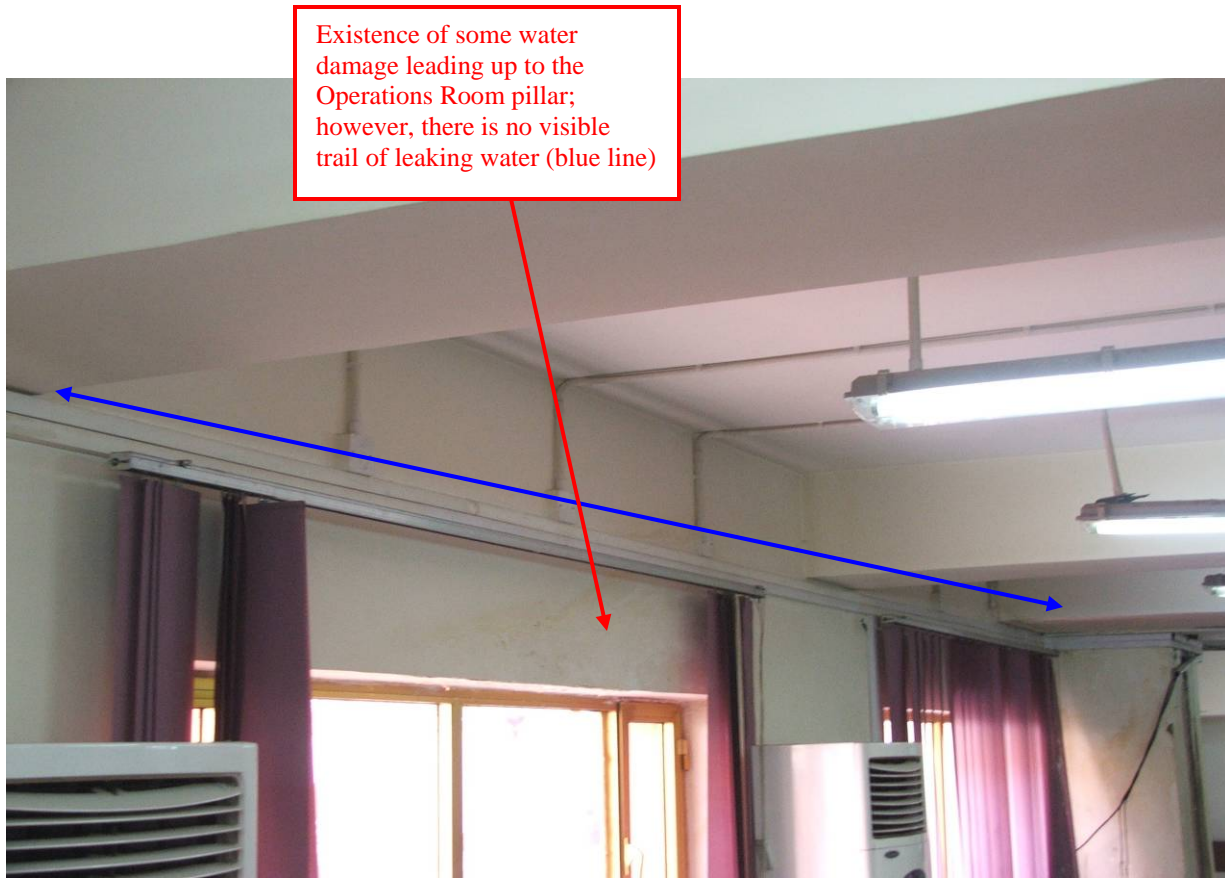
to the wall and the farthest toilet to the wall is approximately 12 feet. Therefore, the area and location of the water damage to the ground floor Operations Room pillar and beam is almost exactly the same area as the sewer lines directly above in the first floor bathrooms.

**Site Photo 27. View of limited water damage on the ground floor Operations Room ceiling**

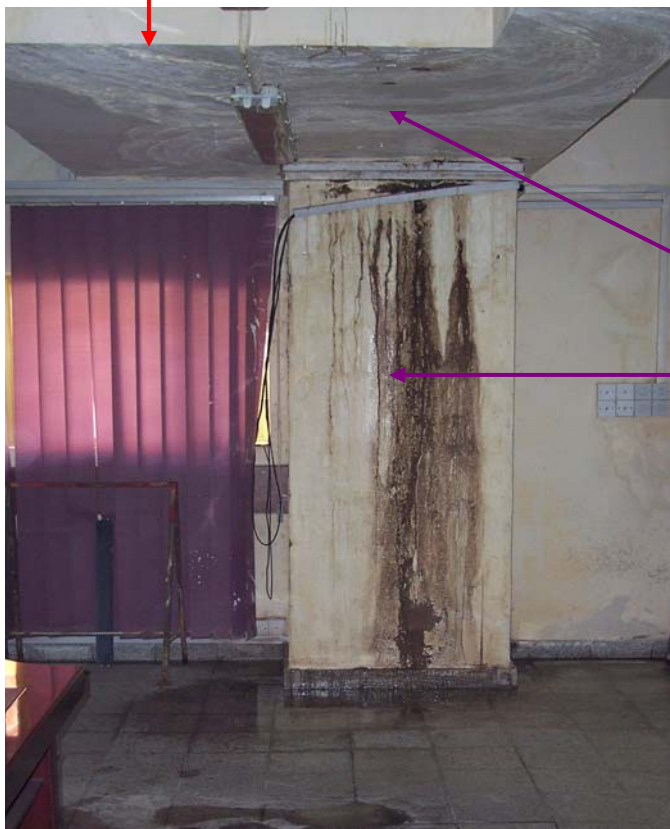
Site Photo 28. End result of poor plumbing installation techniques used in the bathroom directly above this ground floor room

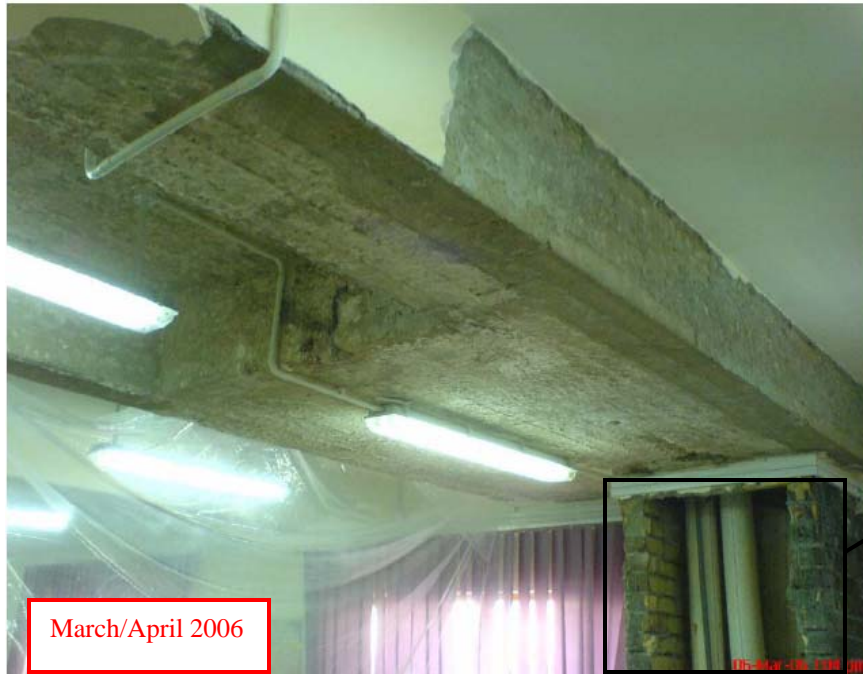
**Site Photo 29. Area of water damage to the ground floor Operations Room replaced by the subcontractor in April 2006**  
(Photo courtesy of the USACE)

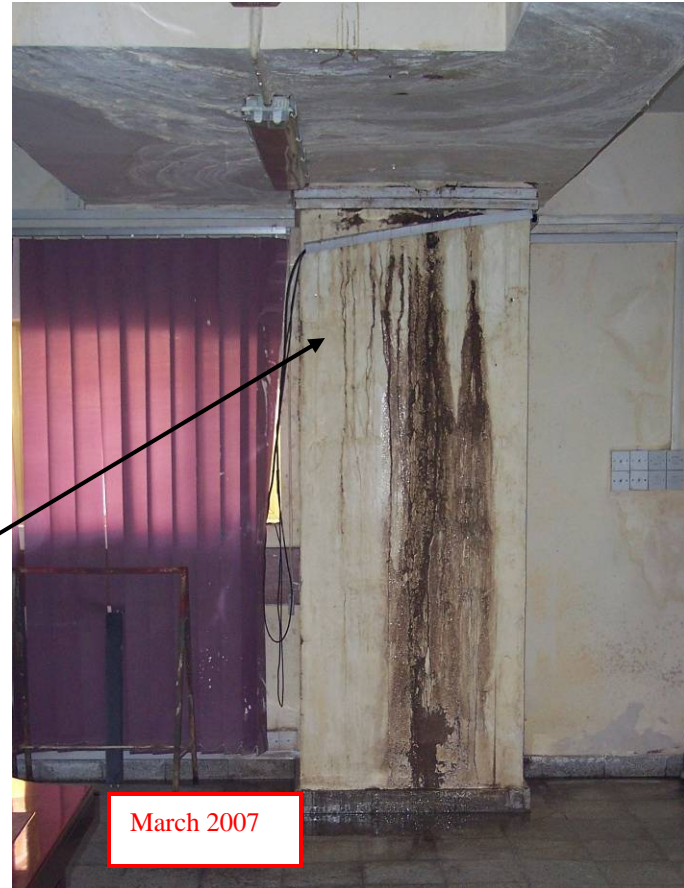
**Site Photo 30. Area of water damage almost identical to previous water damage**

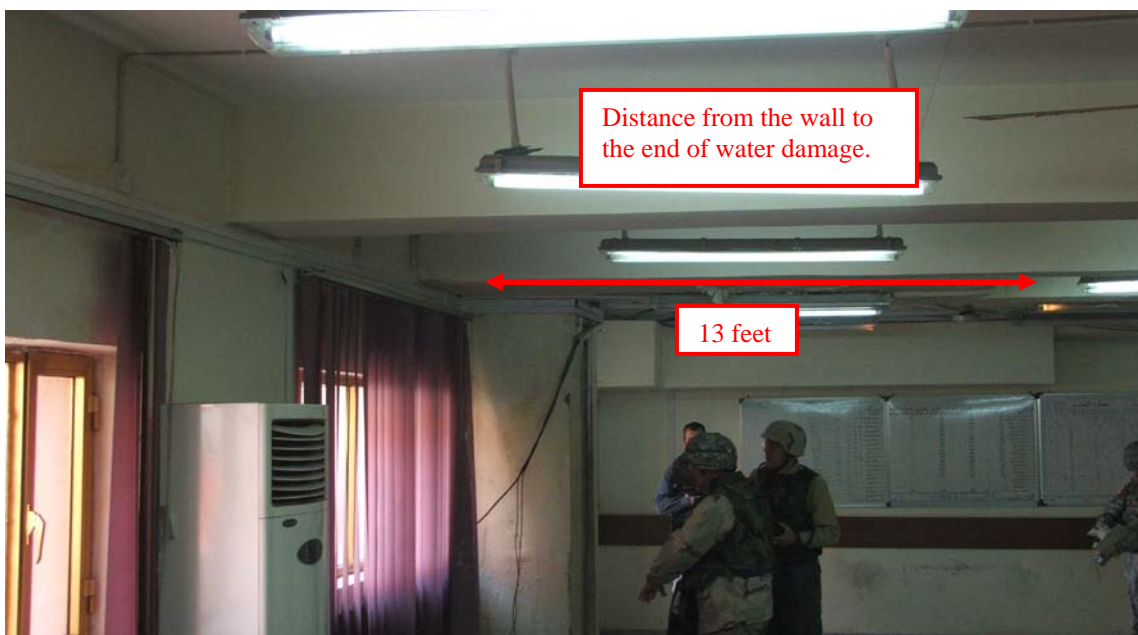
**Site Photo 31. Distance from the wall to the end of water damage within the ground floor Operations Room**

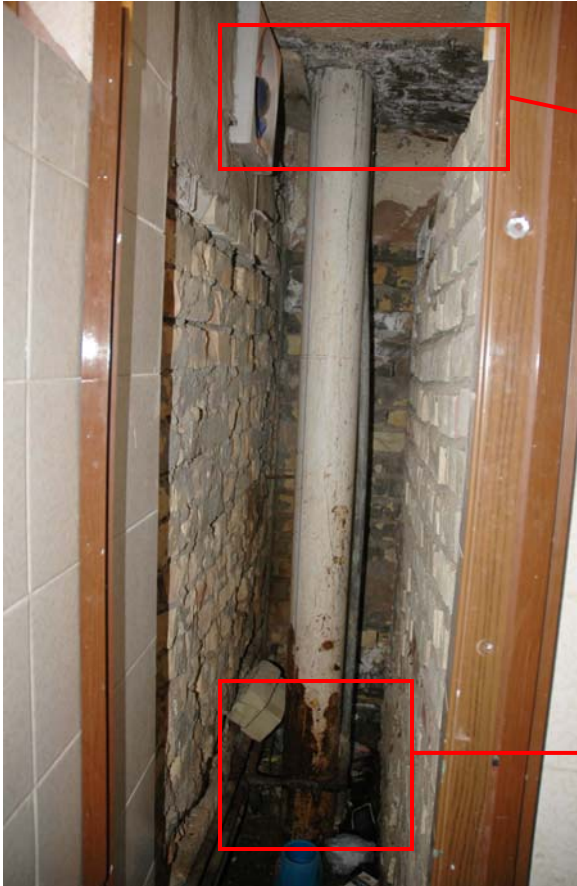
Finally, during our last site visit, in an effort to confirm GRC's theory of water leaking from the first and second floors on the left all the way down to the ground floor Operations Room pillar and beam on the right, we thoroughly inspected the ground floor ceiling. We noticed water damage at various points in the Operations Room; however, these water spots appeared to be old and dried out (Site Photos 36 and 37), while water was still dripping from the ceiling slab of the Operations Room (the slab connected to the pillar) (Site Photo 38). This appeared to disprove GRC's theory that water traveled approximately 37' from left to right within the Operations Room. The more likely scenario is the significant water damage resulted from leaks within the two first floor bathrooms directly on top of the Operations Room beam.

**Site Photo 32. Water damage within the first floor bathroom chase**

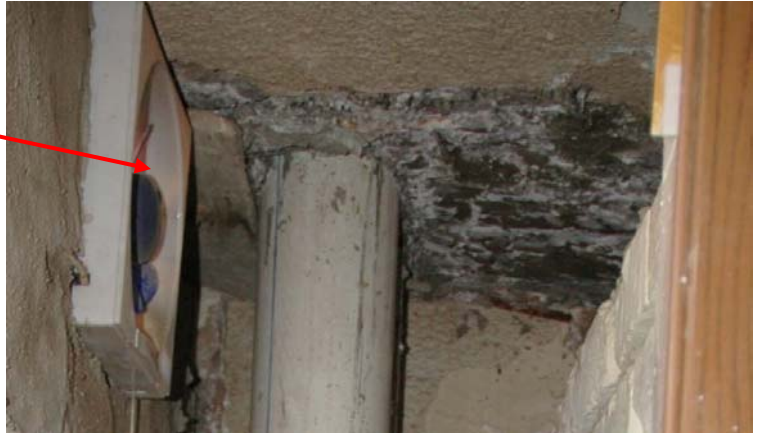
**Site Photo 33. Close up view of top of Site Photo 32**

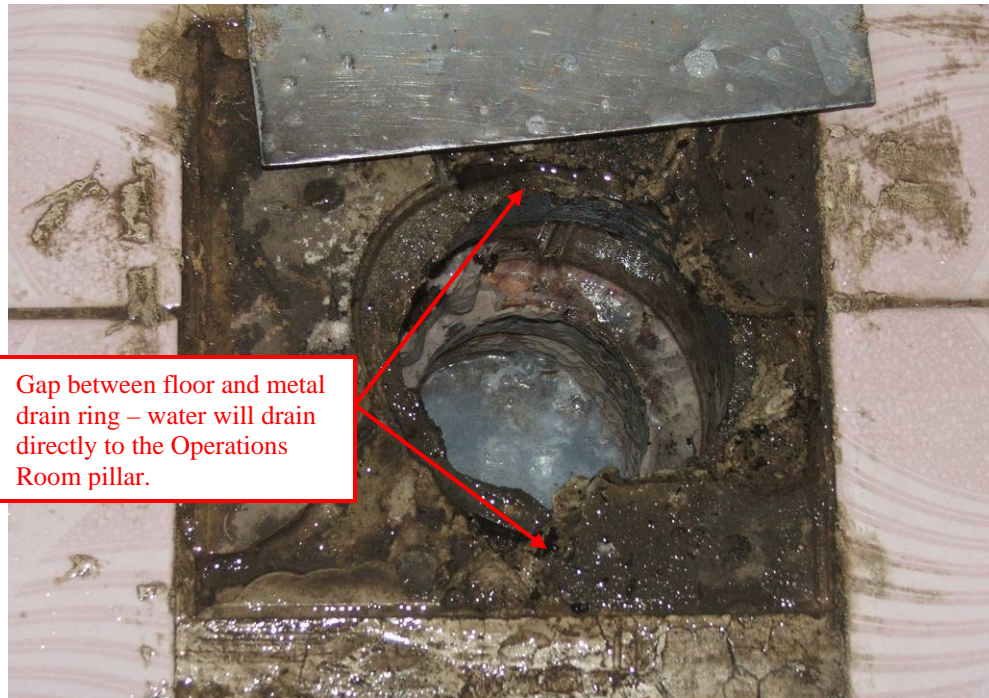
**Site Photo 35. Poorly installed floor drain in the first floor bathroom**

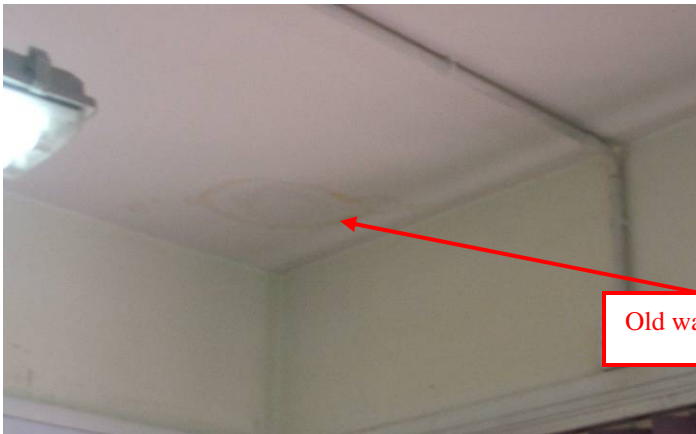
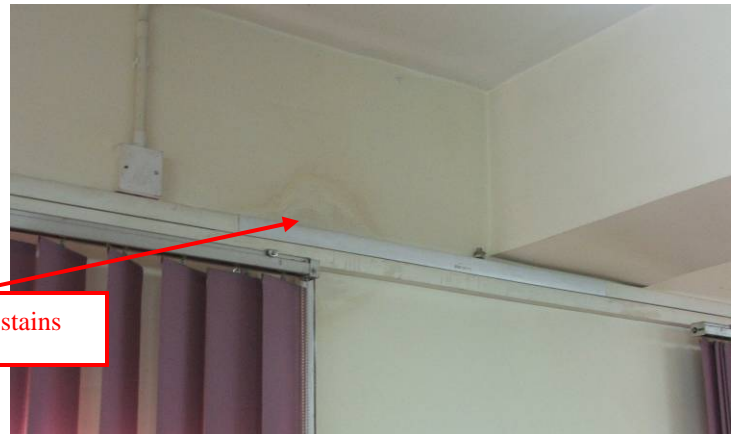
**Site Photos 36 and 37. Old and dried out water spots on the ground floor Operations Room ceiling**

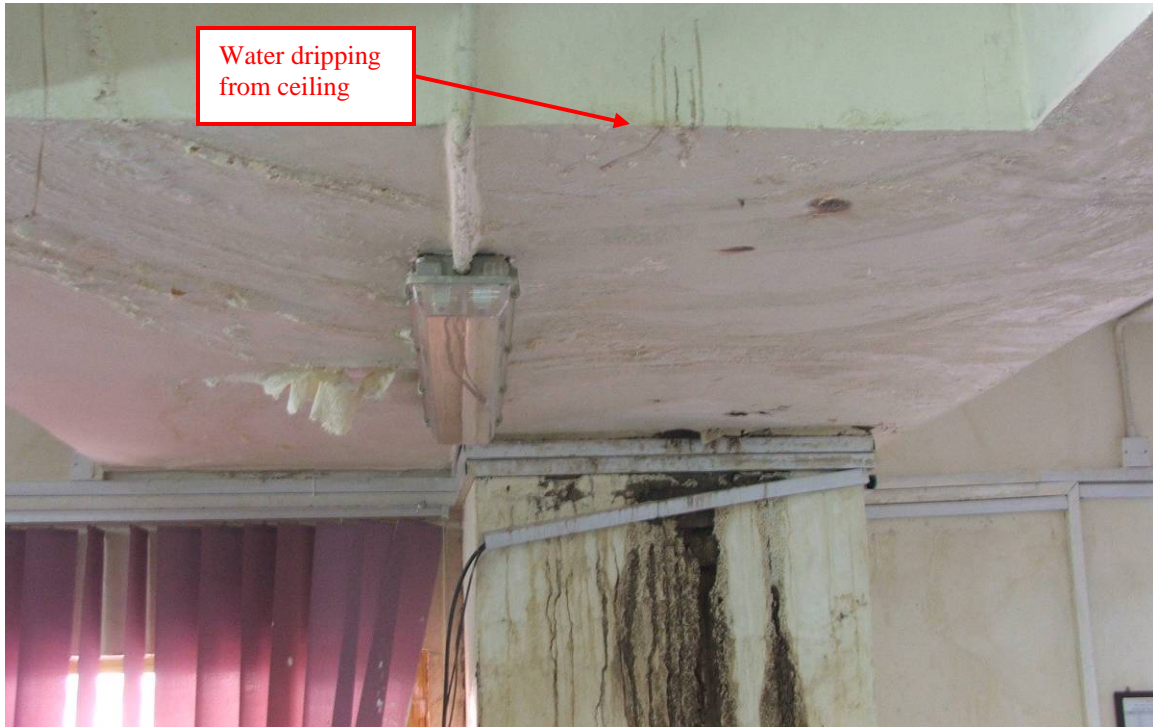
**Site Photo 38. Continuously dripping water on the ground floor Operations Room beam**

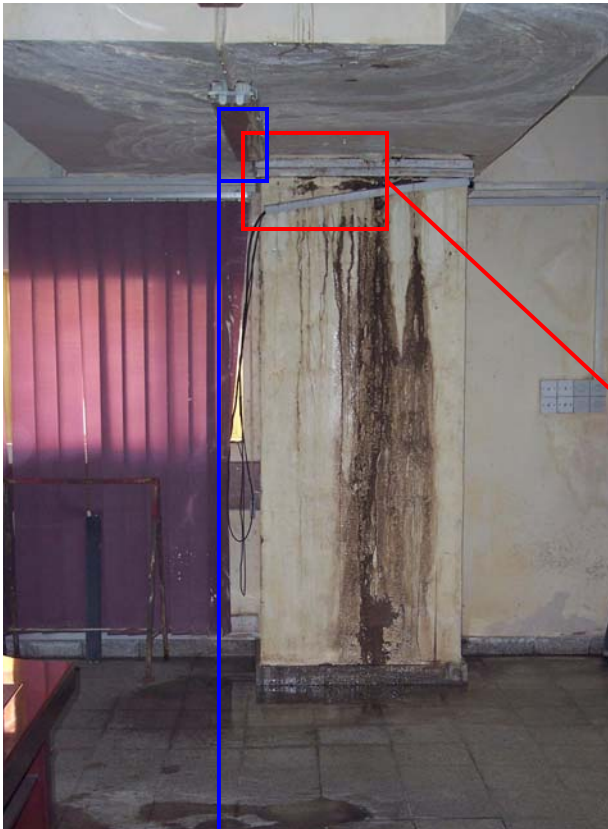
**Site Photo 39. Water damage to ground floor Operations Room**

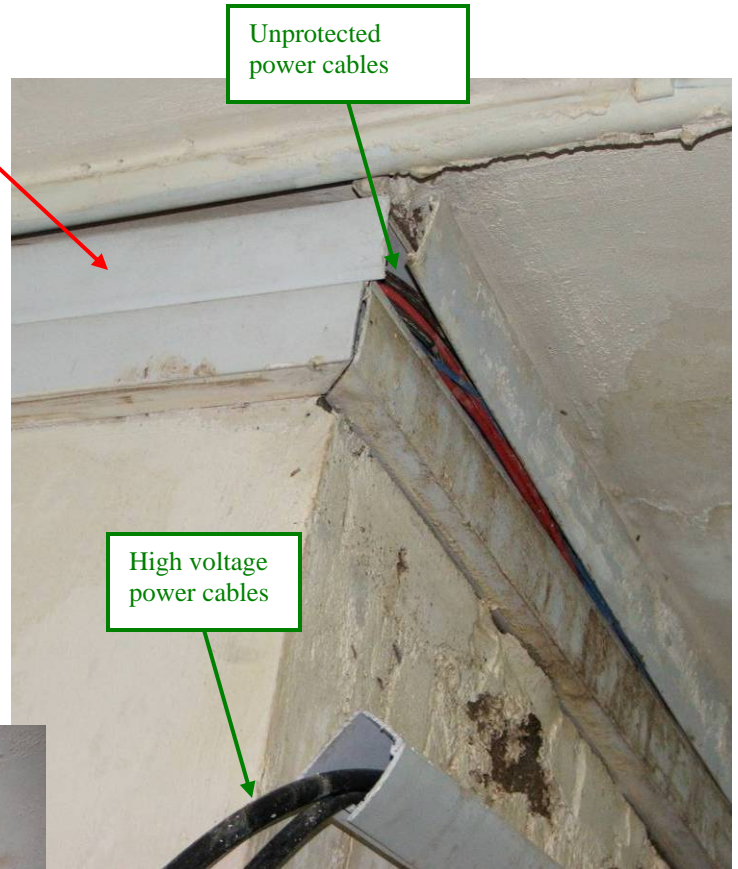
**Site Photo 40. Unprotected live wires exposed to leaking water**

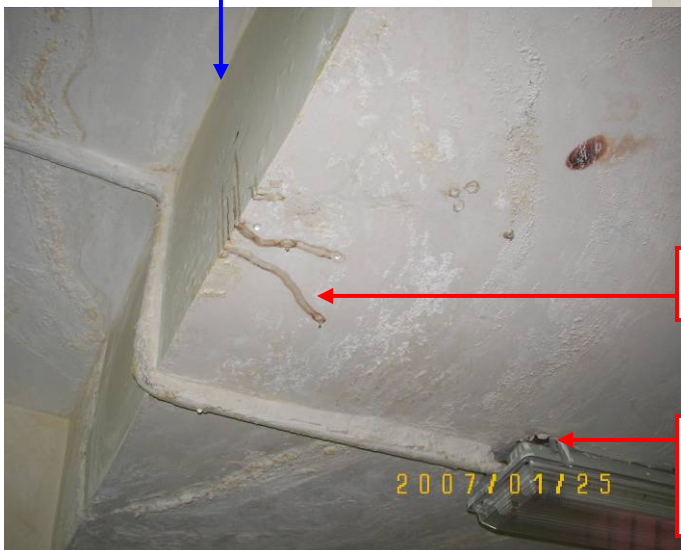
**Site Photo 41. Leaking water on the ceiling and open area of light fixture**

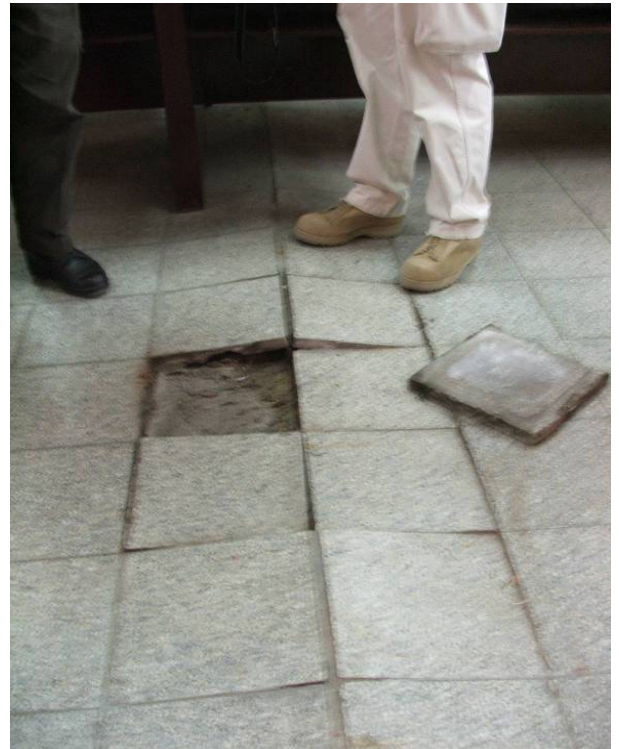
In addition, the water leakage is so pervasive that the ground floor tiles in the Operations Room have buckled (Site Photos 42 and 43).

**Site Photo 43. Additional view of tile buckling**
